**Evaluation of Wall Assemblies Under Racking Load Sheathed
with Raw Gypsum Attached by PEMCO 5100**

**Pemco Adhesives
5120 Beck Drive
Elkhart, IN 46516**

Test Report: NTA96-0212-2

Issued: February 27, 1996

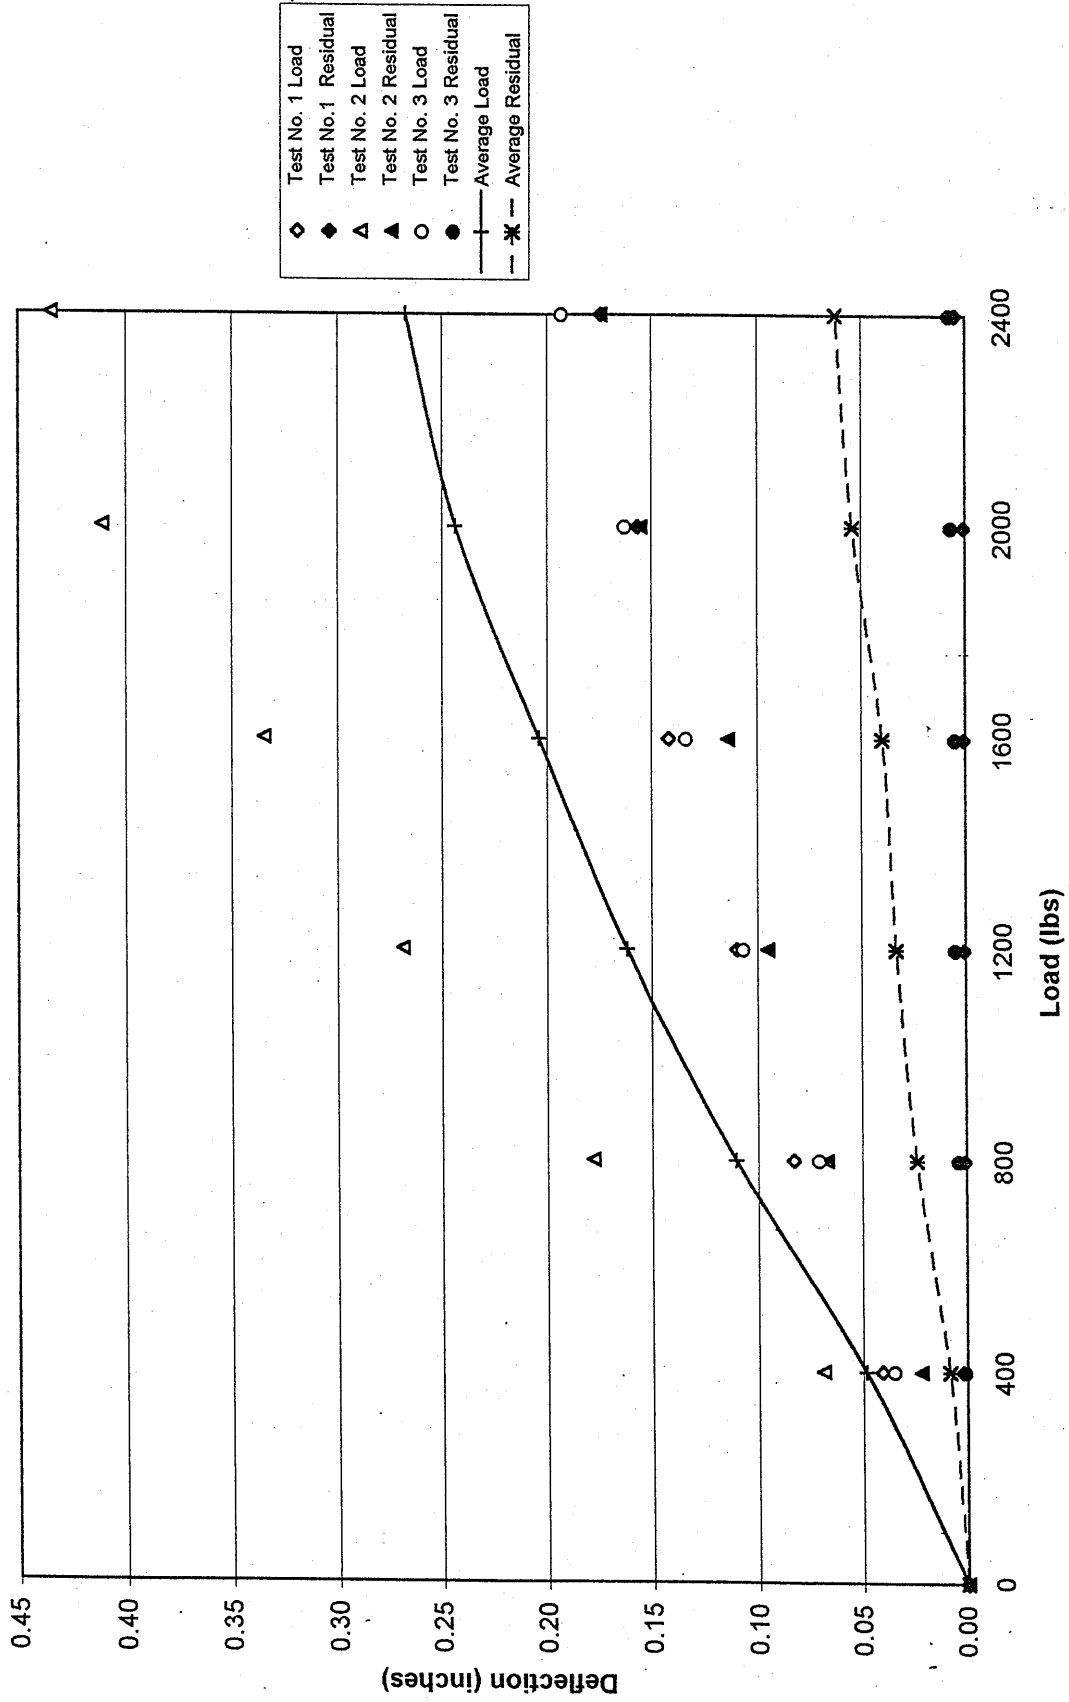
Load Deflection Curves

TIME (sec)	LOAD (lbs)	INDICATOR #1 (in)		INDICATOR #2 (in)		INDICATOR #3 (in)		RESULTANT DEFLECTION (in)
		READING	DEFLECTION	READING	DEFLECTION	READING	DEFLECTION	
8:00 AM	0	0.117		0.145		0.137		ALL INDICATORS
8:01 AM	400	0.167	0.050	0.145	0.000	0.128	0.009	0.041
8:02 AM	0	0.120	0.003	0.145	0.000	0.136	0.001	0.002
8:04 AM	800	0.219	0.102	0.145	0.000	0.118	0.019	0.083
8:06 AM	0	0.125	0.008	0.141	0.004	0.134	0.003	0.001
8:09 AM	1200	0.264	0.147	0.141	0.004	0.104	0.033	0.110
8:12 AM	0	0.129	0.012	0.139	0.006	0.132	0.005	0.001
8:16 AM	1600	0.314	0.197	0.142	0.003	0.085	0.052	0.142
8:20 AM	0	0.134	0.017	0.136	0.009	0.130	0.007	0.001
8:25 AM	2000	0.357	0.240	0.134	0.011	0.065	0.072	0.157
8:30 AM	0	0.137	0.020	0.136	0.009	0.127	0.010	0.001
8:36 AM	2400	0.409	0.292	0.130	0.015	0.034	0.103	0.174
8:42 AM	0	0.151	0.034	0.128	0.017	0.125	0.012	0.005

<u>TEST SAMPLE</u>	<u>MAX. LOAD</u>	<u>FAILURE MODE</u>
#1	6041 Lbs.	Gypsum shear at 1st bay of 2nd panel
#2	4764 Lbs.	Paper failure at last stud of 2nd panel
#3	6403 Lbs.	Gypsum shear at 1st bay of 2nd panel

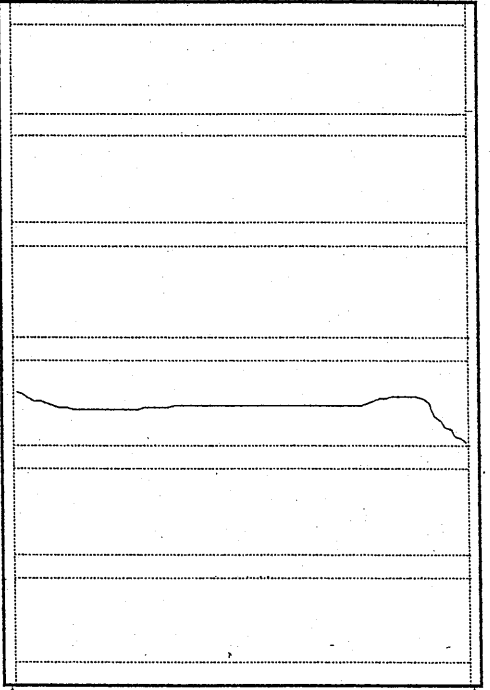
Location of Failure and Dial Indicator Placement

LOAD AT FAILURE: 6041 LBS
 MODE OF FAILURE: Gypsum Shear at 1st bay of 2nd panel along between studs.

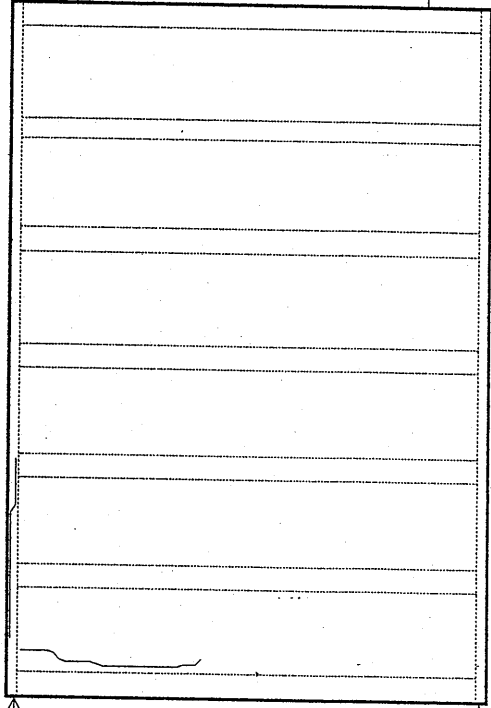
Location of Failure and Dial Indicator Placement

LOAD AT FAILURE: 4764 LBS

MODE OF FAILURE: Paper failure along top plate and gypsum failure along last stud in 2nd panel

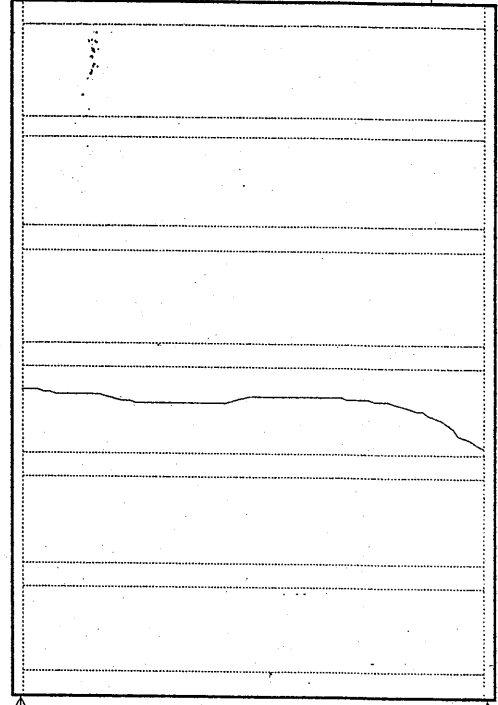
Location of Failure and Dial Indicator Placement

LOAD AT FAILURE: **6403 LBS**

MODE OF FAILURE: Gypsum shear at 1st bay of 2nd panel between studs.

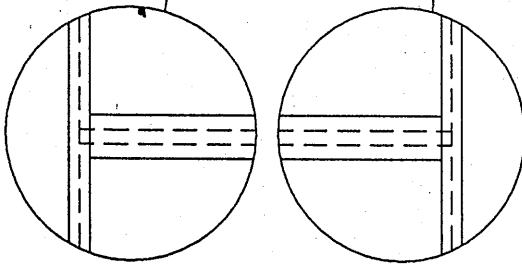
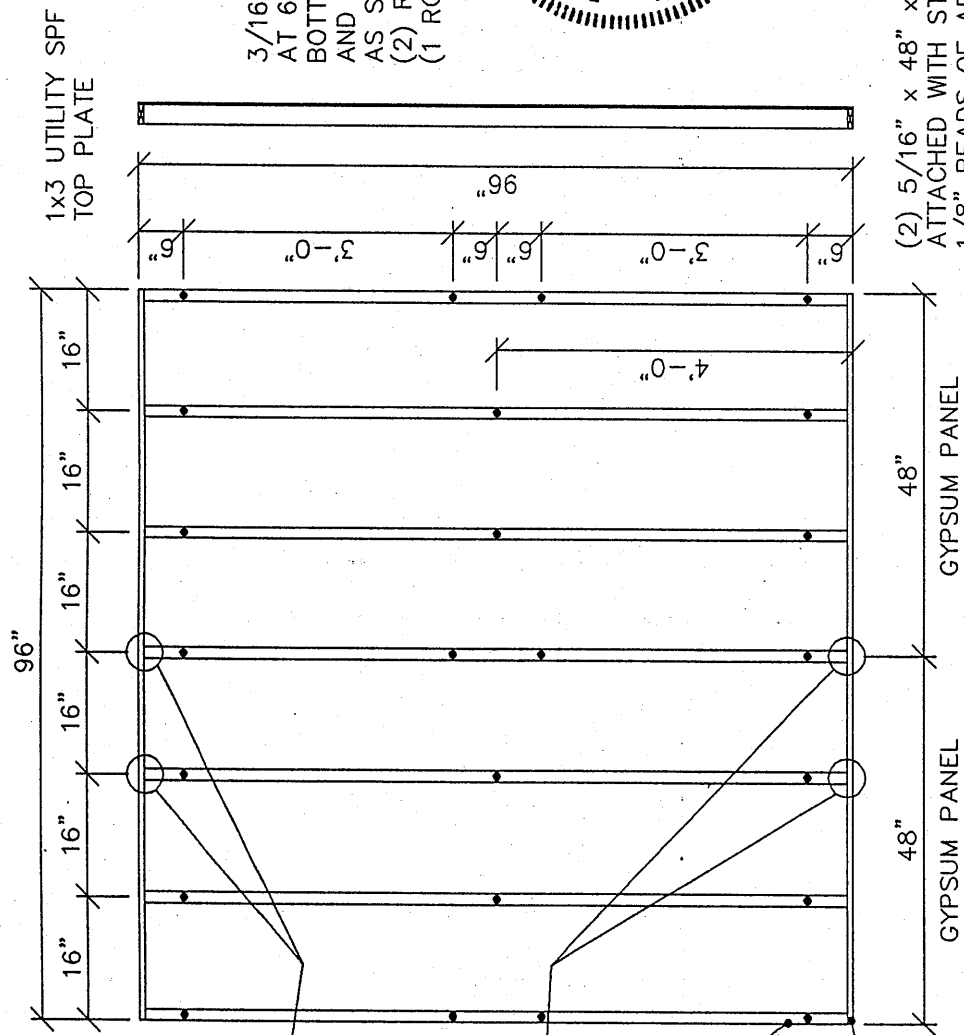
REVISIONS:	SCALE: N.T.S.	APPROVED BY:
MODEL: W212-2US	DATE: 02/26/96	PROJECT NO: NTA96-0212-2
TITLE: WALL PANEL	DRAWN BY: P.N.	DRAWING NO: FIGURE #1
NTA, INC.		
305 NORTH OAKLAND AVENUE, NAPPANEE, IN. 46550

TOP PLATE FASTENED WITH
(2) 7/16" x 2" x 16ga
STAPLES AT EACH STUD END.

TYPICAL ADHESIVE PATTERN

2x3 STUD GRADE
SPF STUDS 16" O.C.

1x3 UTILITY SPF
BOTTOM PLATE

BOTTOM PLATE FASTENED WITH
(2) 7/16" x 2" x 16ga
STAPLES AT EACH STUD END.

3/16" x 3/4" x 19ga STAPLES
AT 6" O.C. ALONG TOP AND
BOTTOM PLATES. PERIMETER
AND FIELD FASTENING FOR STUDS
AS SHOWN. CENTER STUD HAS
(2) ROWS OF FASTENERS
(1 ROW PER PANEL).

(2) 5/16" x 48" x 96" U.S. GYPSUM PANELS
ATTACHED WITH STAPLES AND TWO 1/16" TO
1/8" BEADS OF ADHESIVE ALL STUDS AND
ONE BEAD OF ADHESIVE ON TOP AND BOTTOM
PLATES.

ADHESIVE = PEMCO 5100
DESIGN SHEAR = 286.8 PLF

1. Top plate attached to studs with (2) 7/16" X 2" X 16 ga. staples per stud.
2. Bottom plate attached to studs with (2) 7/16" X 2" X 16 ga. staples per stud end.
3. Gypsum attached to 2 X 3 studs with (2) 1/16" to 1/8" (average) beads of PEMCO 5100 adhesive.
4. Gypsum attached to 1 X 3 top plate with (1) 1/16" to 1/8" (average) bead of PEMCO 5100 adhesive.
5. Gypsum attached to 1 X 3 bottom plate with (1) 1/16" (average) bead of PEMCO 5100 adhesive.
6. Gypsum attached to framing with 3/16" X 3/4" X 19 ga. staples at 6" o.c. along top and bottom plates. Gypsum was also edge secured 6" from plates at each stud and 1 fastener 6" above and below mid height of studs on gypsum perimeter. Stud field fasteners were placed at mid height of stud. See Figure #1 for representation.

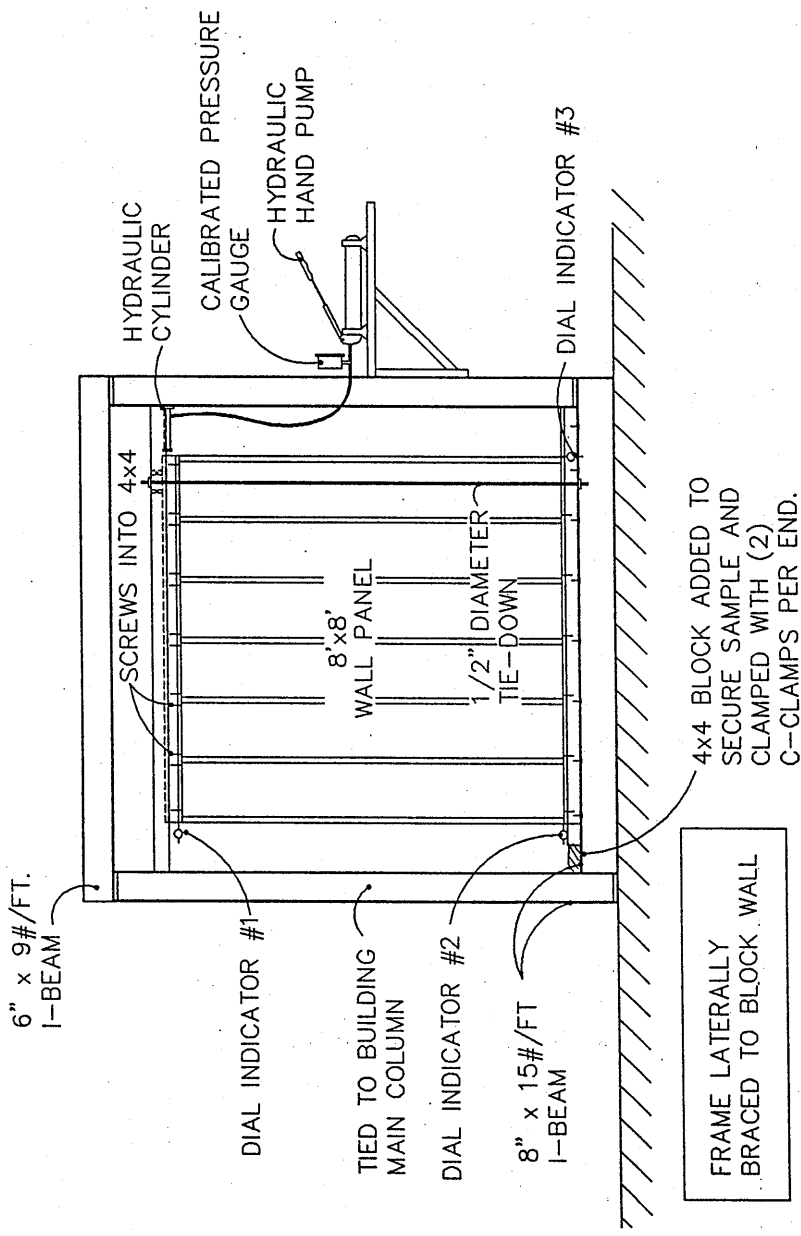
TITLE: RACKING TEST FIXTURE

FRAME LATERALLY
 BRACED TO BLOCK WALL

4x4 BLOCK ADDED TO
 SECURE SAMPLE AND
 CLAMPED WITH (2)
 C-CLAMPS PER END.

The top and bottom plates were attached to 4 X 4s with (3) - #8 X 2-1/2" screws per bay. The 4X4 was then secured by adding a 4X4 block between the 4x4 and the Vertical I-beam. The block and 4X4 were then secured to the horizontal I-beam using 2 C-clamps per end.

Load was applied horizontally to the 4 X 4 attached to the top plate of the wall. Dial indicators were placed on the top plate (indicator #1) and bottom plate (indicator #2) opposite the loaded end of the wall. An additional dial indicator was placed at the load end of the wall at the base of the rack on the first stud (indicator #3). See figure #2 for details.

To determine the horizontal deflection of the panel, deflection readings from indicator #2 and #3 were subtracted from indicator #1. Indicator #3 which is attached to the stud measures any rotation of the panel. Indicator #2 measures any slippage of the panel in the test rack. Indicator #1 measures the total of indicators #2 and #3 plus the deformation of the panel.
