ALPHA SYSTEMS, INC.

Evaluation of Sheathing Materials - Racking Load
Alphaseal 5200 & Georgia-Pacific Gypsum

98-2966
(A)

WALL TEST - RACKING LOAD

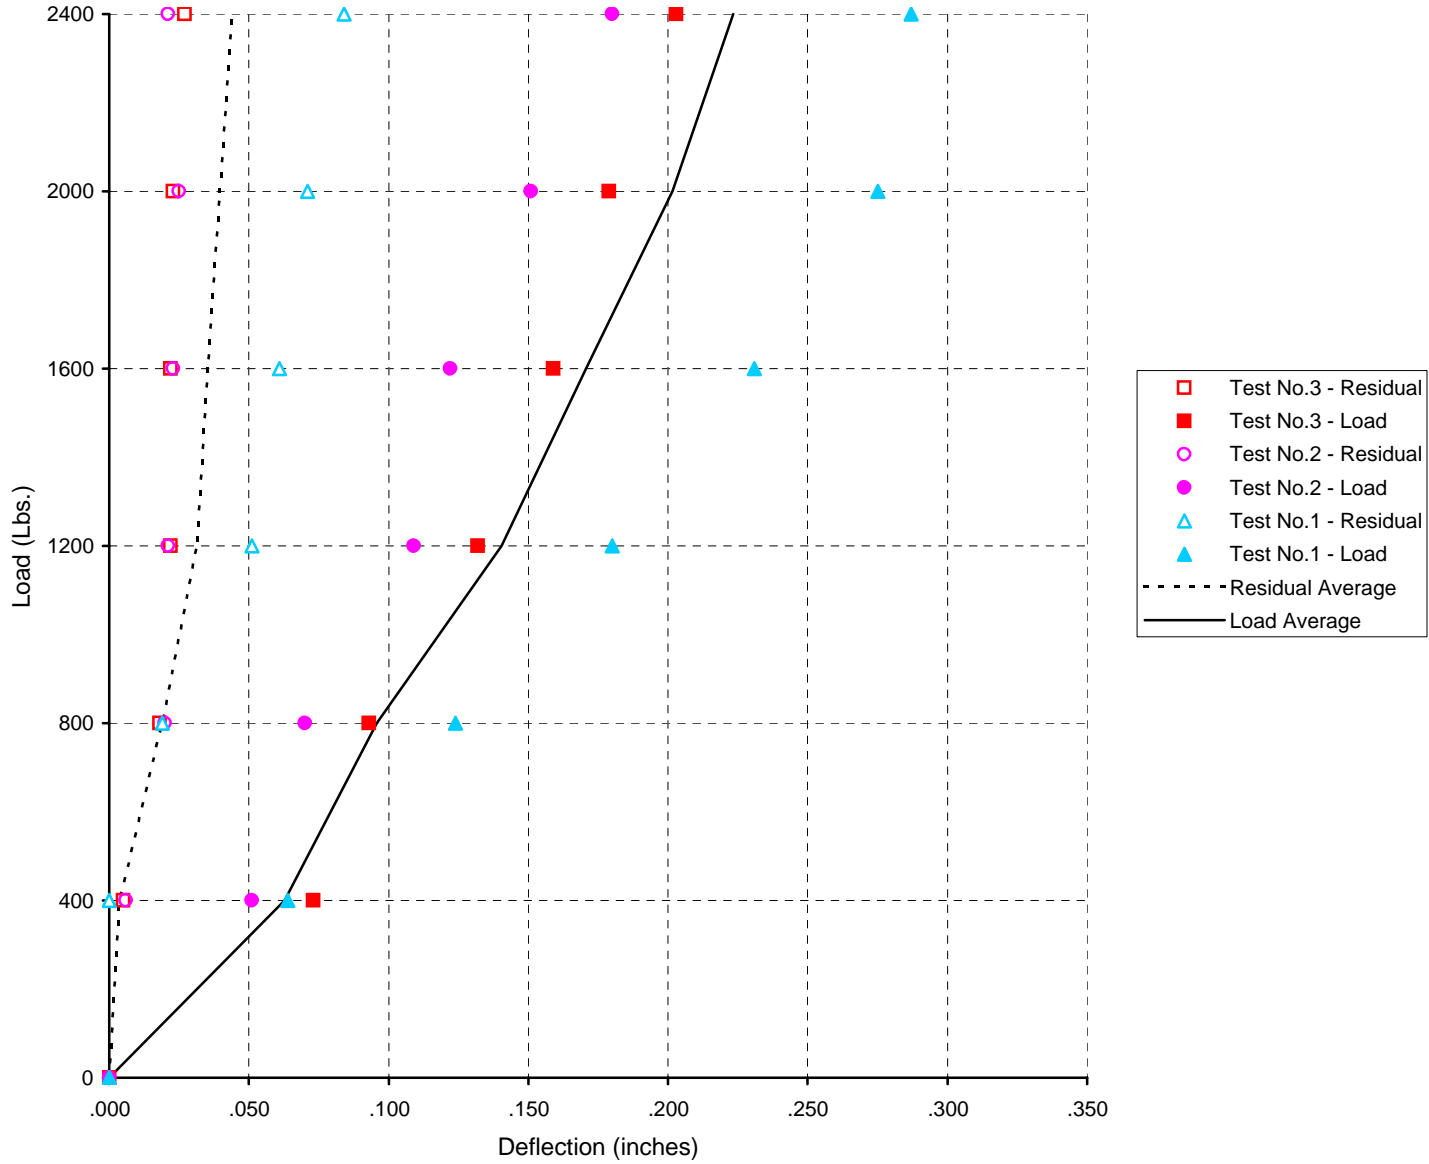
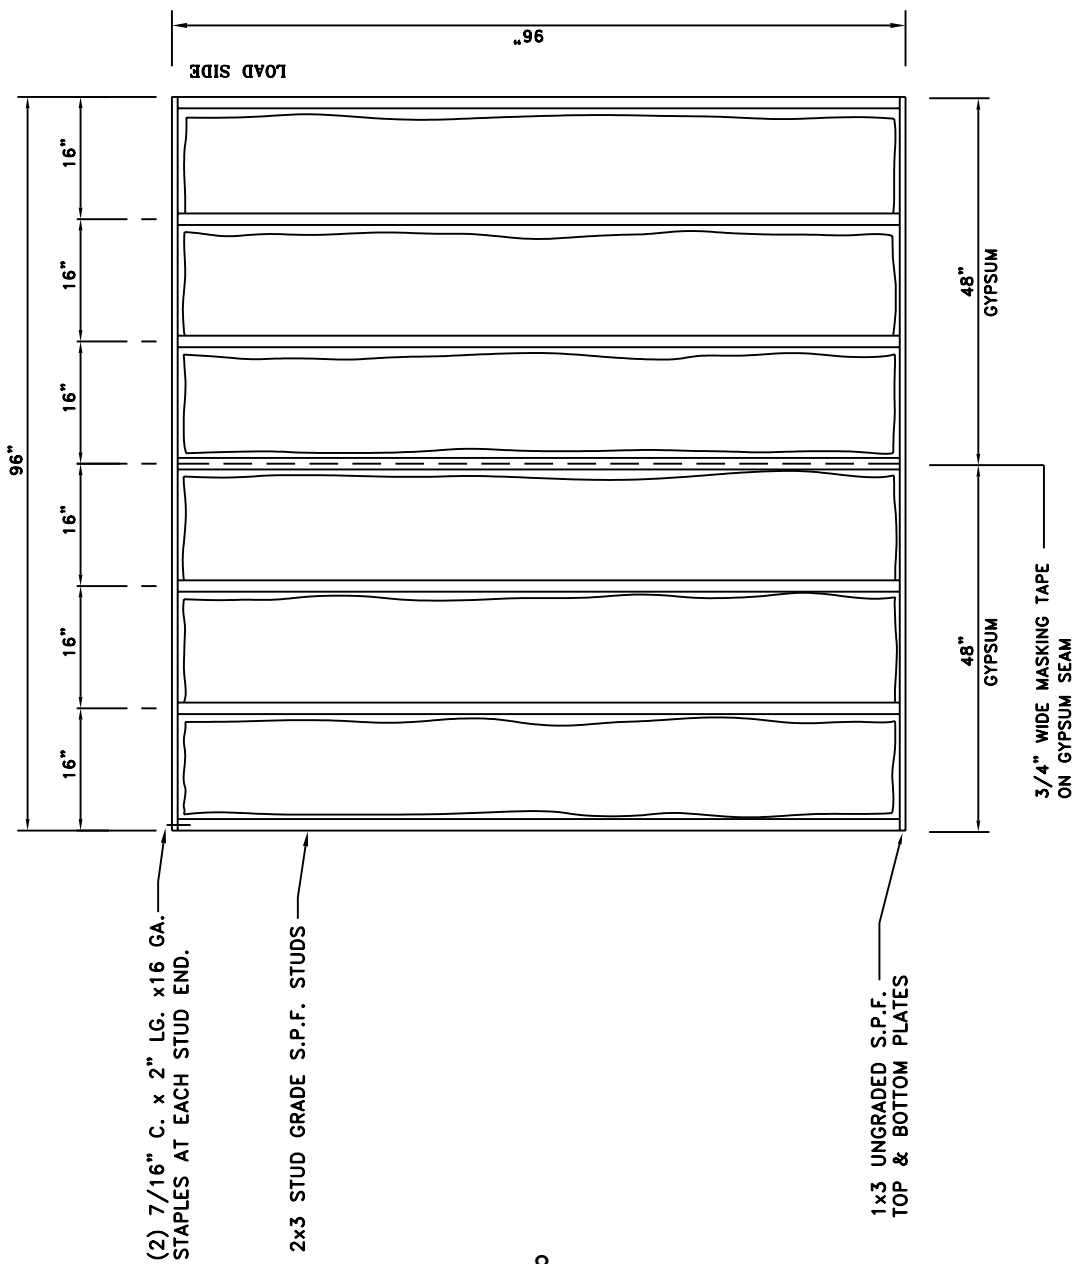
Single Sided Wall

(2) 7/16" C. x 2" LG. x16 GA. STAPLES AT EACH STUD END.

2x3 STUD GRADE S.P.F. STUDS

1x3 UNGRADED S.P.F. TOP & BOTTOM PLATES

48" GYPSUM

3/4" WIDE MASKING TAPE ON GYPSUM SEAM

TWO (2) PIECES OF 48"x96"x5/16" GEORGIA PACIFIC GYPSUM-GYPSUM WAS FASTENED WITH ALPHASEAL 5200 TWO-PART URETHANE ADHESIVE.

AVERAGE AMOUNT OF 5200 CONTACT AREA:
ON THE STUDS = 1/2"
ON THE PLATES = 1/2"
ON THE GYPSUM = 3/4"

MEASURED GAP OF 0" TO 3/16" BETWEEN GYPSUM & STUDS

AVERAGE MEASURED GAP OF 1/16" BETWEEN GYPSUM & PLATES

- I. Two (2) pieces of gypsum were laid on a flat wall jig.
- II. The previously constructed framework was laid on the gypsum such that the center 2 x 3 stud was parallel with and directly over the gypsum seam.

- III. A 1/16" wood spacer was placed between the top plate and the gypsum at the center location and both ends. The wood spacers were approximately 3/4" x 1/2" and the measured thickness ranged between .062" to .065".

- VI. The average contact area of the Alphaseal 5200 on the side of the field studs was 7/16".
The average contact area of the Alphaseal 5200 on the side of the plates, center stud and outside studs was 1/2".
The average contact area of the Alphaseal 5200 on the gypsum for field studs was 11/16".
The average contact area of the Alphaseal 5200 on the gypsum for the plates, center studs and outside studs was 1".

- A. 2 x 3 studs at 16" o.c. with 1 x 3 top and bottom plates as framing.
- B. 5/16" (or thicker) x 48" x 96" Georgia-Pacific gypsum board with seams vertical.
- C. Alphaseal 5200 two-part urethane adhesive applied as shown on attached drawing.

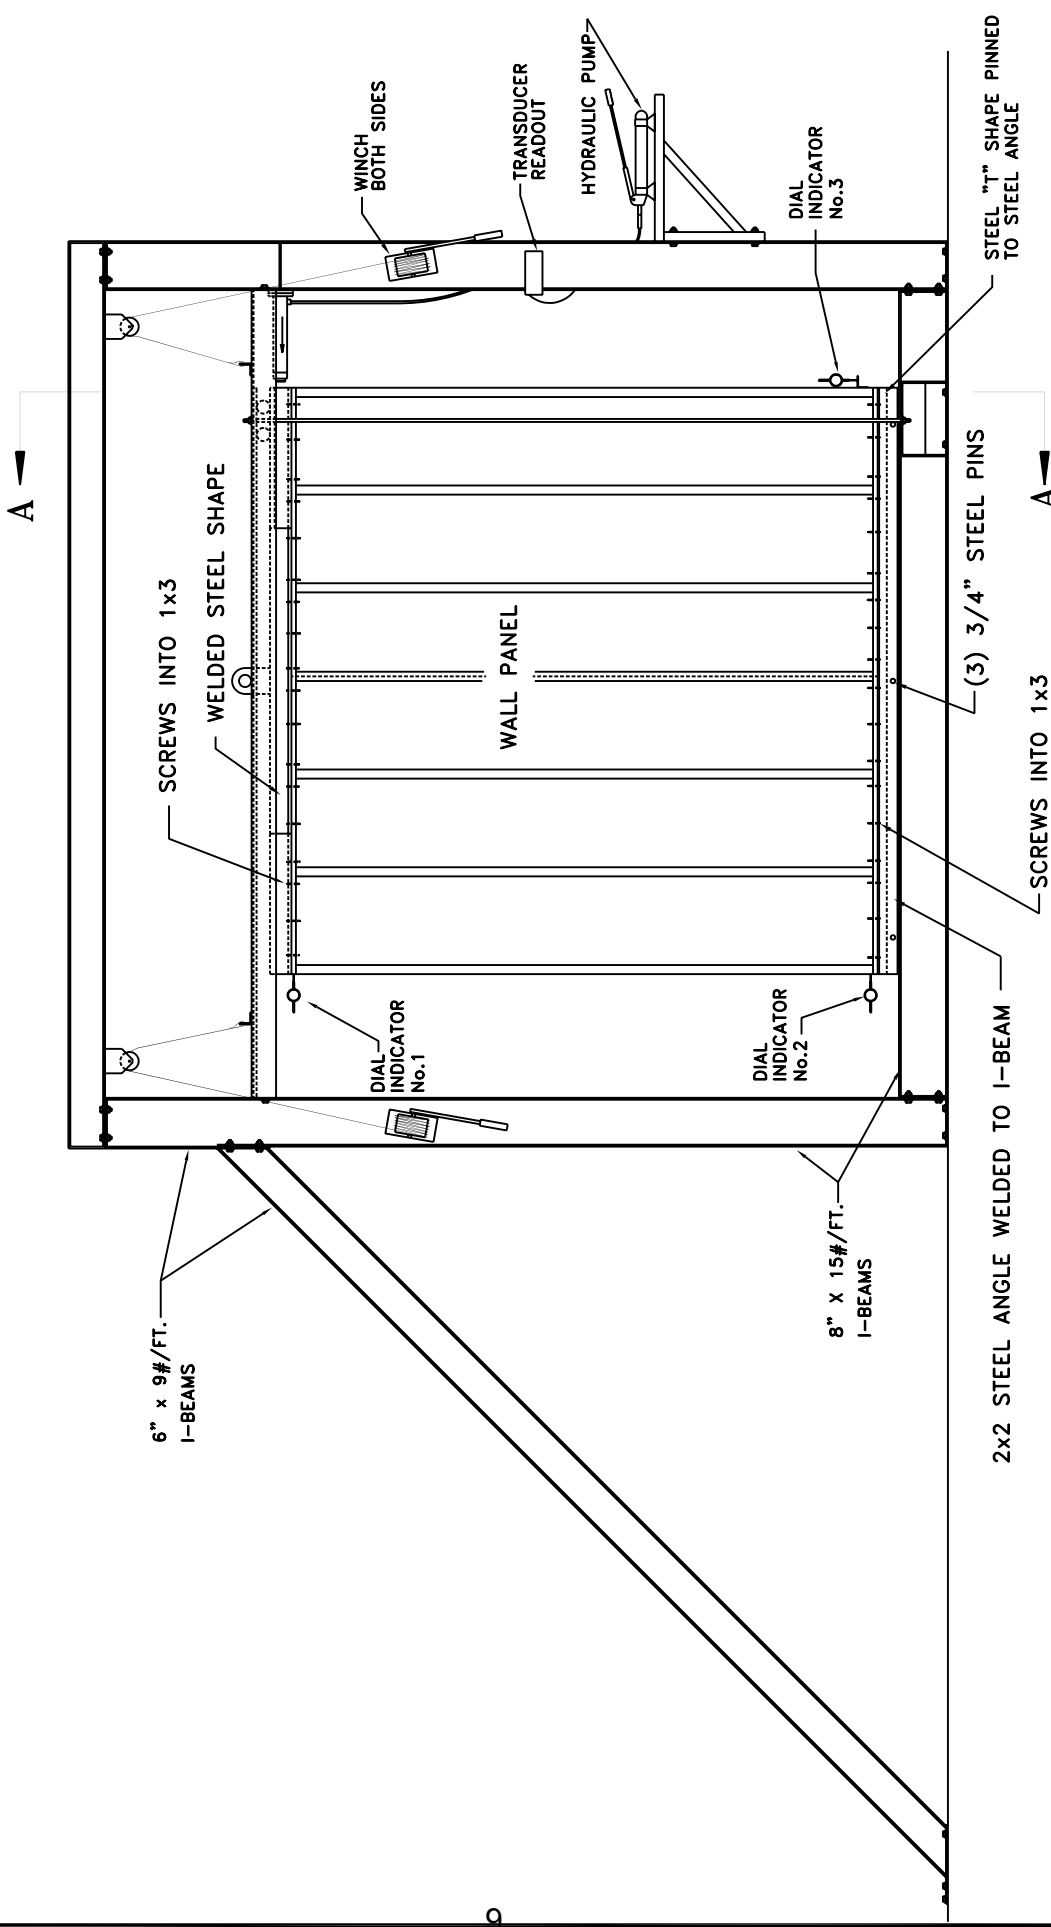
DWN. BY: D. LEHMAN
 DATE: 10/2/98
 SCALE: NONE
 DRAWING NUMBER
 F641

TITLE: TEST SET-UP

A steel beam, with a steel plate welded to the ends, was screwed to the top plate using 2" lg. hex head screws. A t-shaped beam was fastened to the bottom plate using 2" hex head screws. The screws were used in a pattern of 6" - 6" - 4", with a stagger of 1". The bottom I-beam of the fixture has a 2" x 2" x 96" lg. steel angle welded to it. There are three (3) steel pegs 3/4" diameter welded the steel angle at center and a 42½" in either direction. The bottom beam has three (3) 3/4" diameter holes that fit the pegs. C-clamps were used at each end of the bottom beam to restrict the wall from falling off the pegs. See attached drawings for further details.

A. Load was applied horizontally to the steel beam which was fastened to the top plate of the wall. Dial indicators were placed at the end of the top and bottom plates opposite the load side of the wall. A dial indicator was also placed on the load side of the wall at the bottom of the first stud. See attached drawing for details.

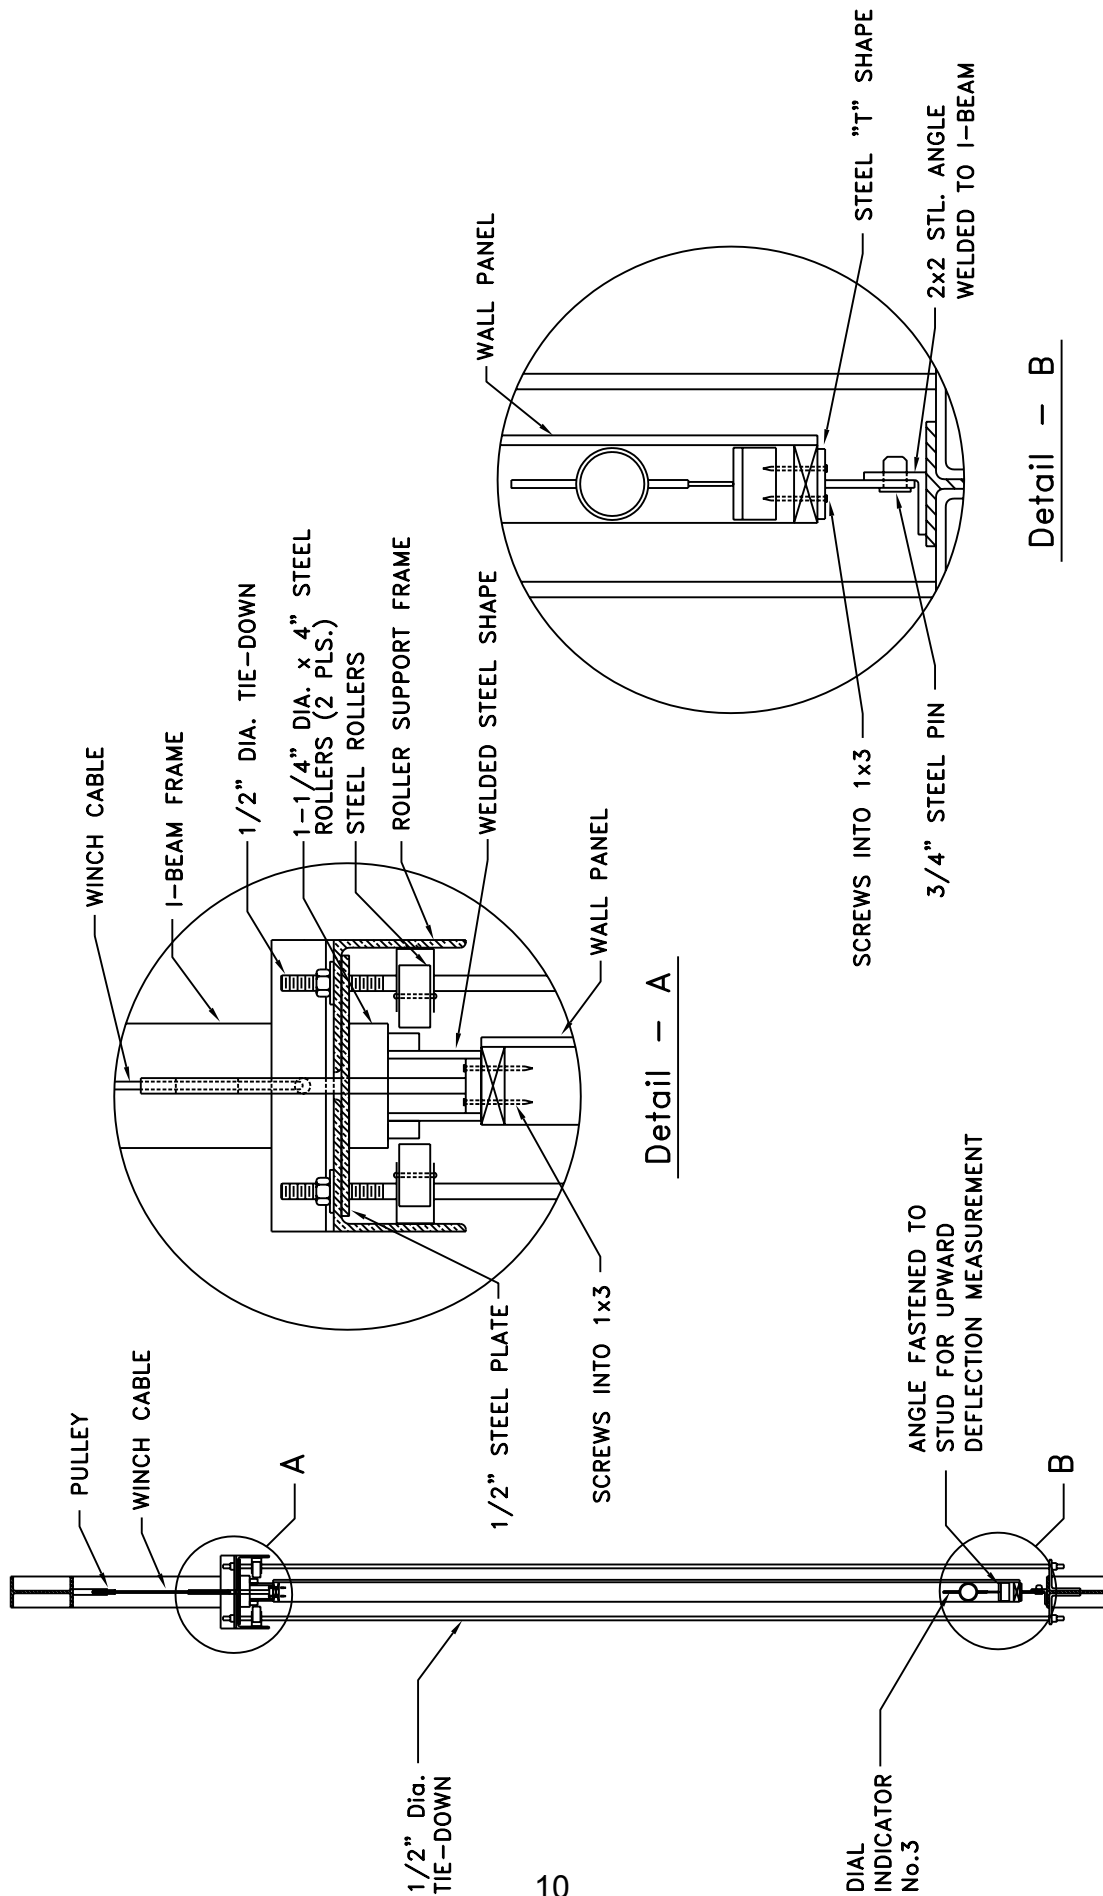
SECTION A-A

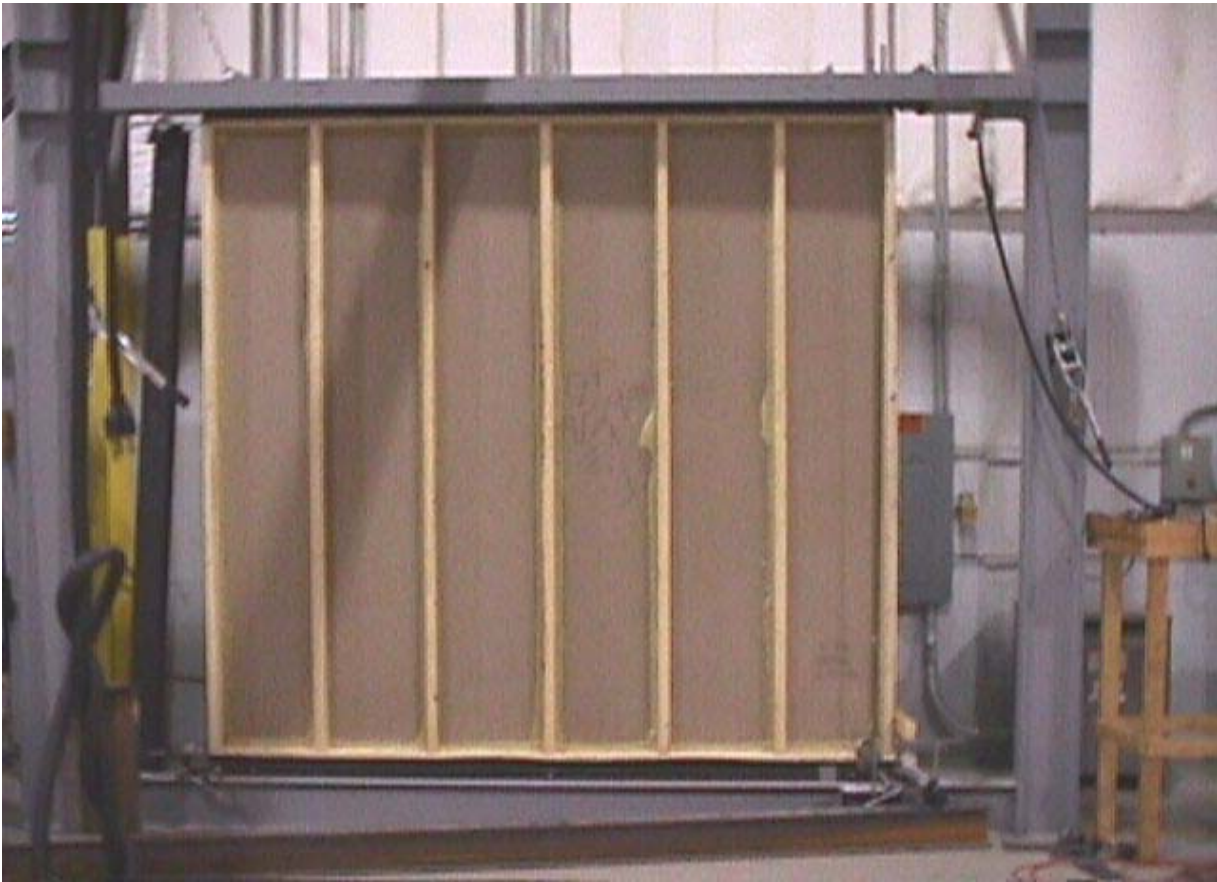
Test Set-Up

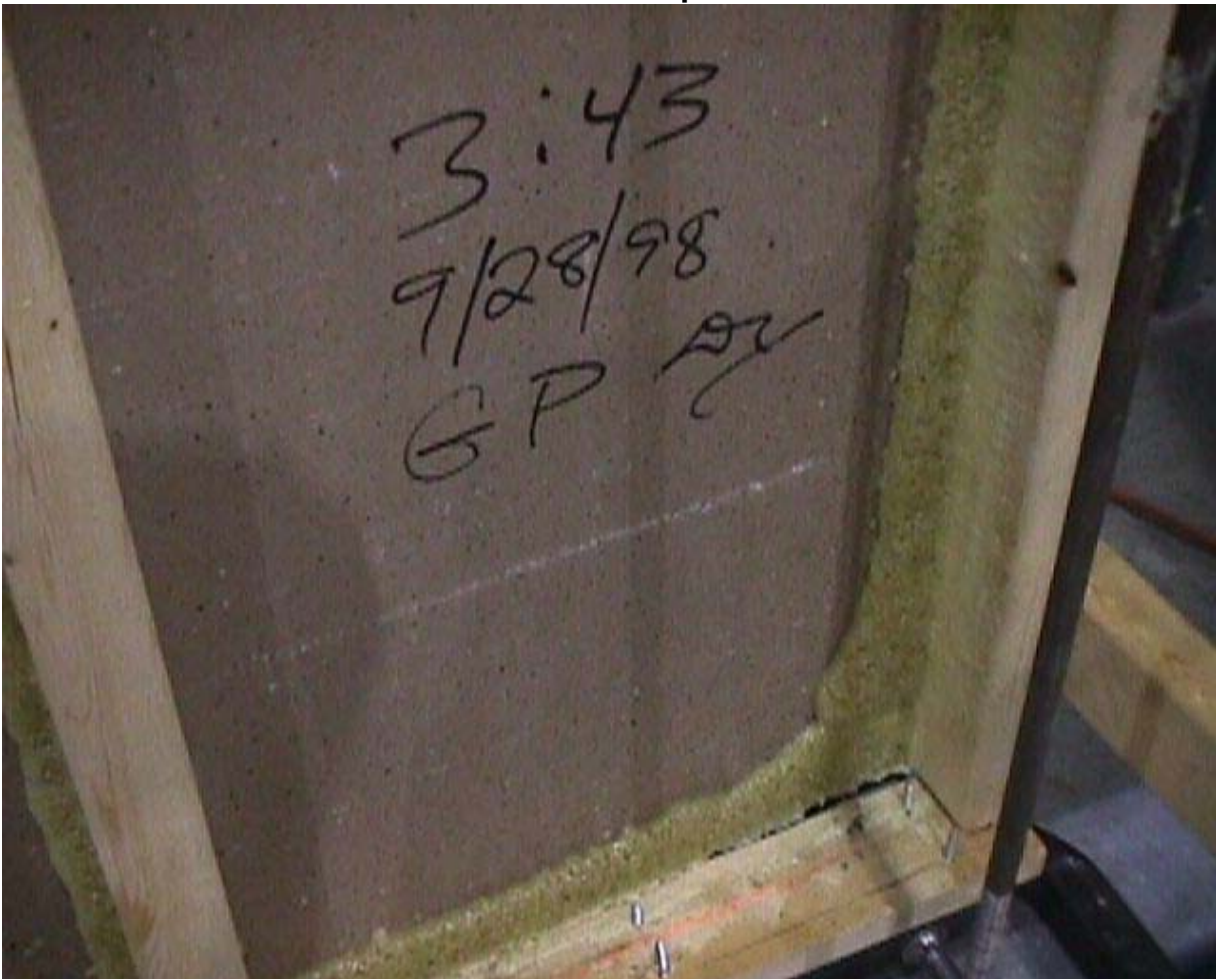
Test No. 1 at Failed Area

max. load reached 6104 Lbs.

Mode of Failure: Foam shear from bottom plate load side of center stud.

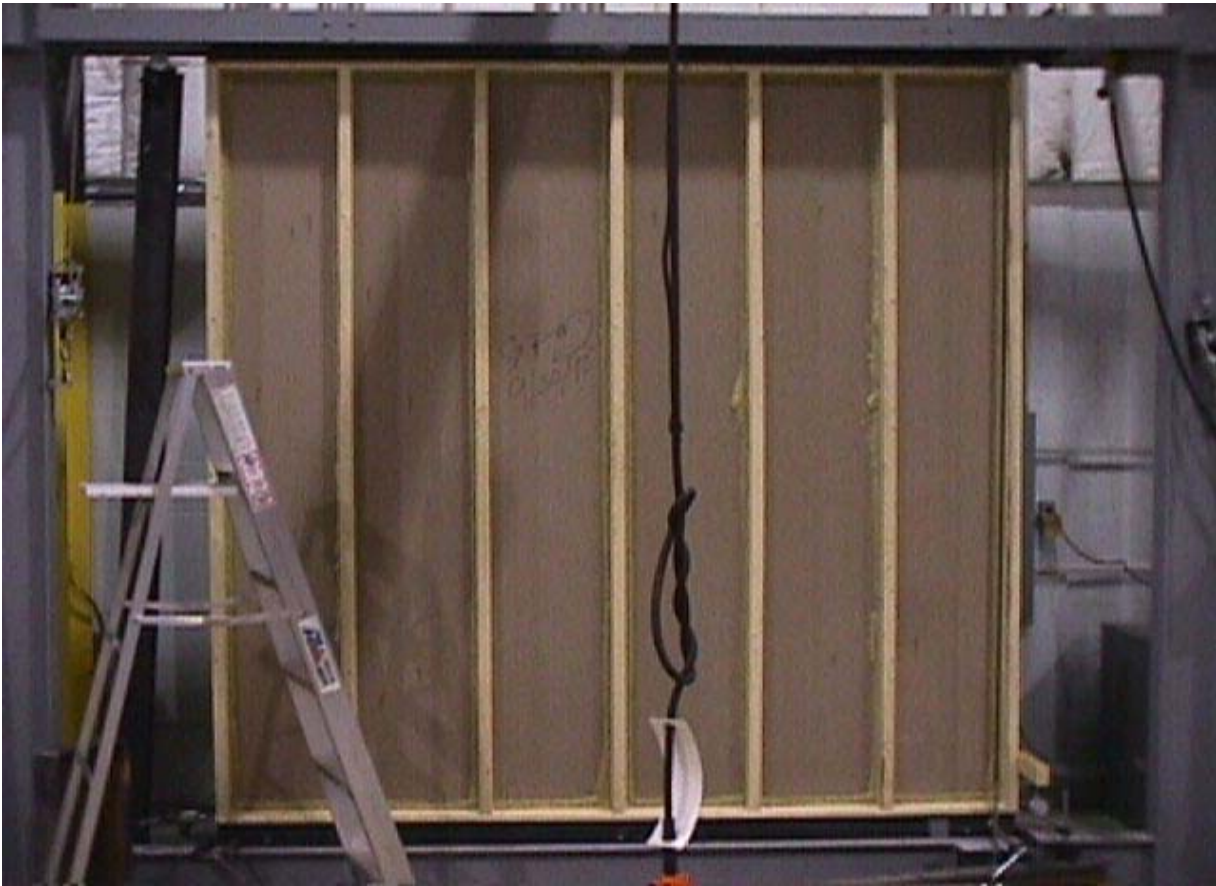
Test Set-Up

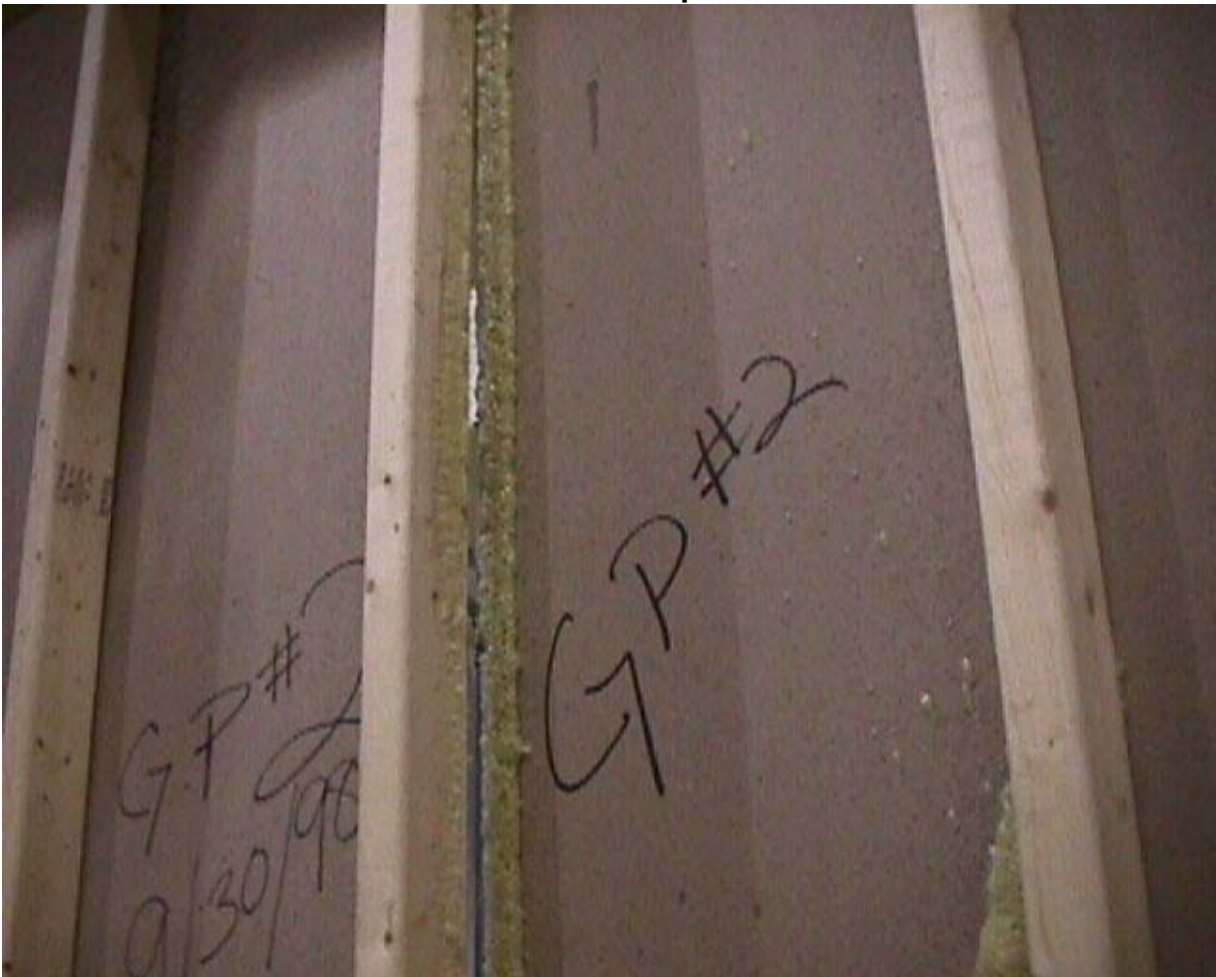
Test No. 2 at Failed Area

max. load reached 5561 Lbs.

Mode of Failure: Foam shear from the top plate on the load side of the center stud.

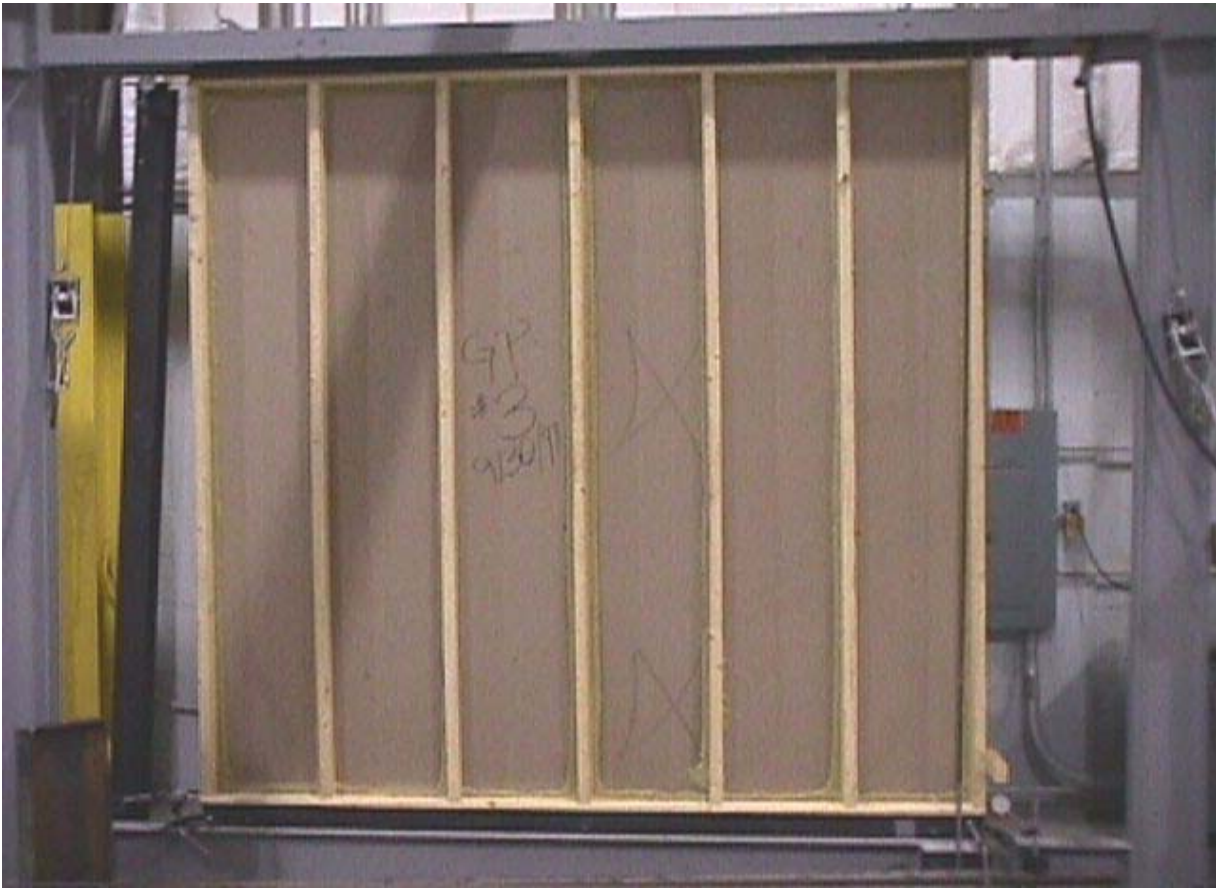
Test Set-up

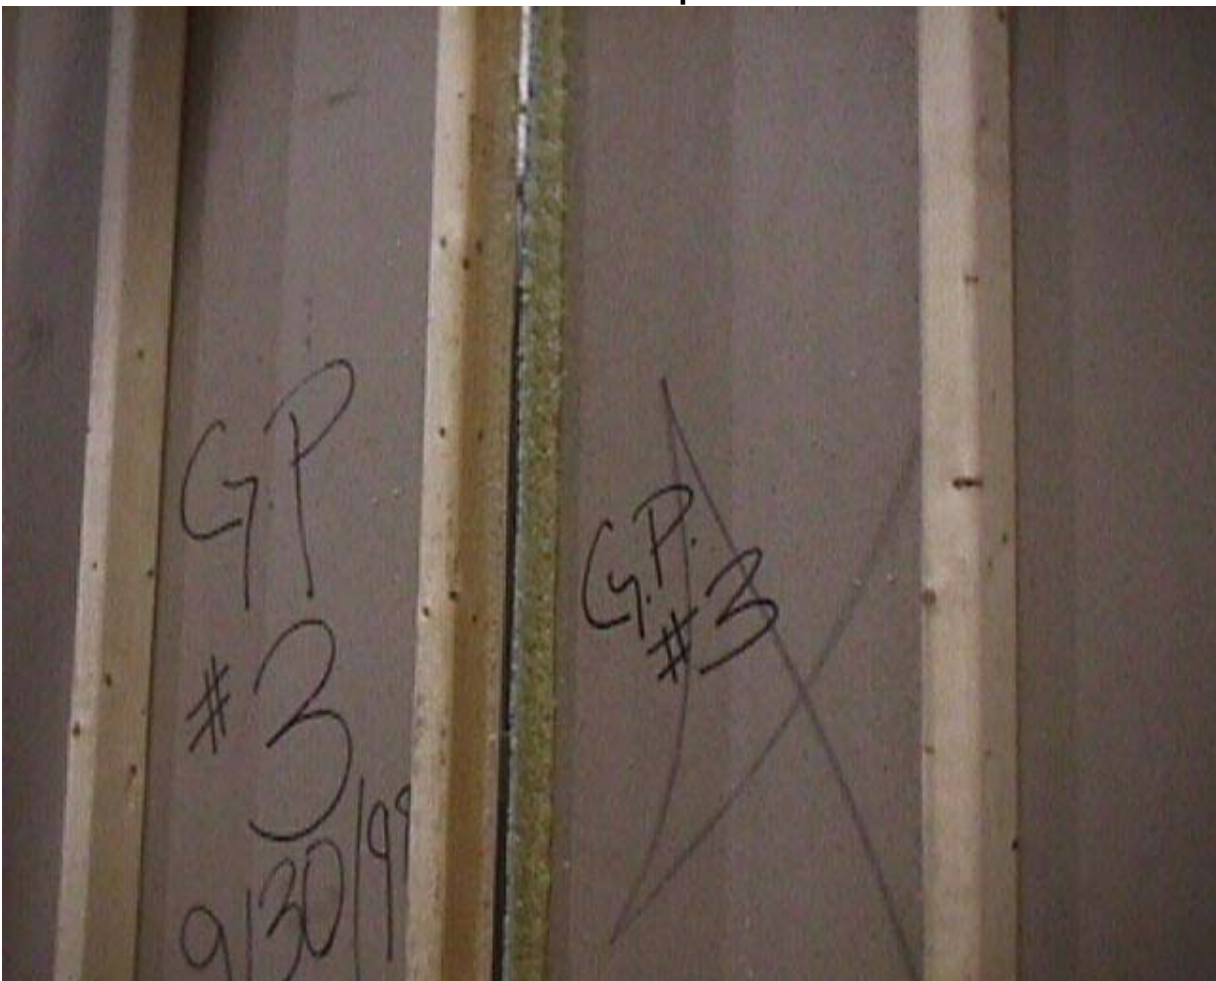
Test No. 3 at Failed Area

max. load reached 6036 Lbs.

Mode of Failure: Foam shear from the top plate on the load side of the center stud
